Chip Errata for the i.MX 6Solo/6DualLite

This document details the silicon errata known at the time of publication for the i.MX 6Solo/6DualLite multimedia applications processors.

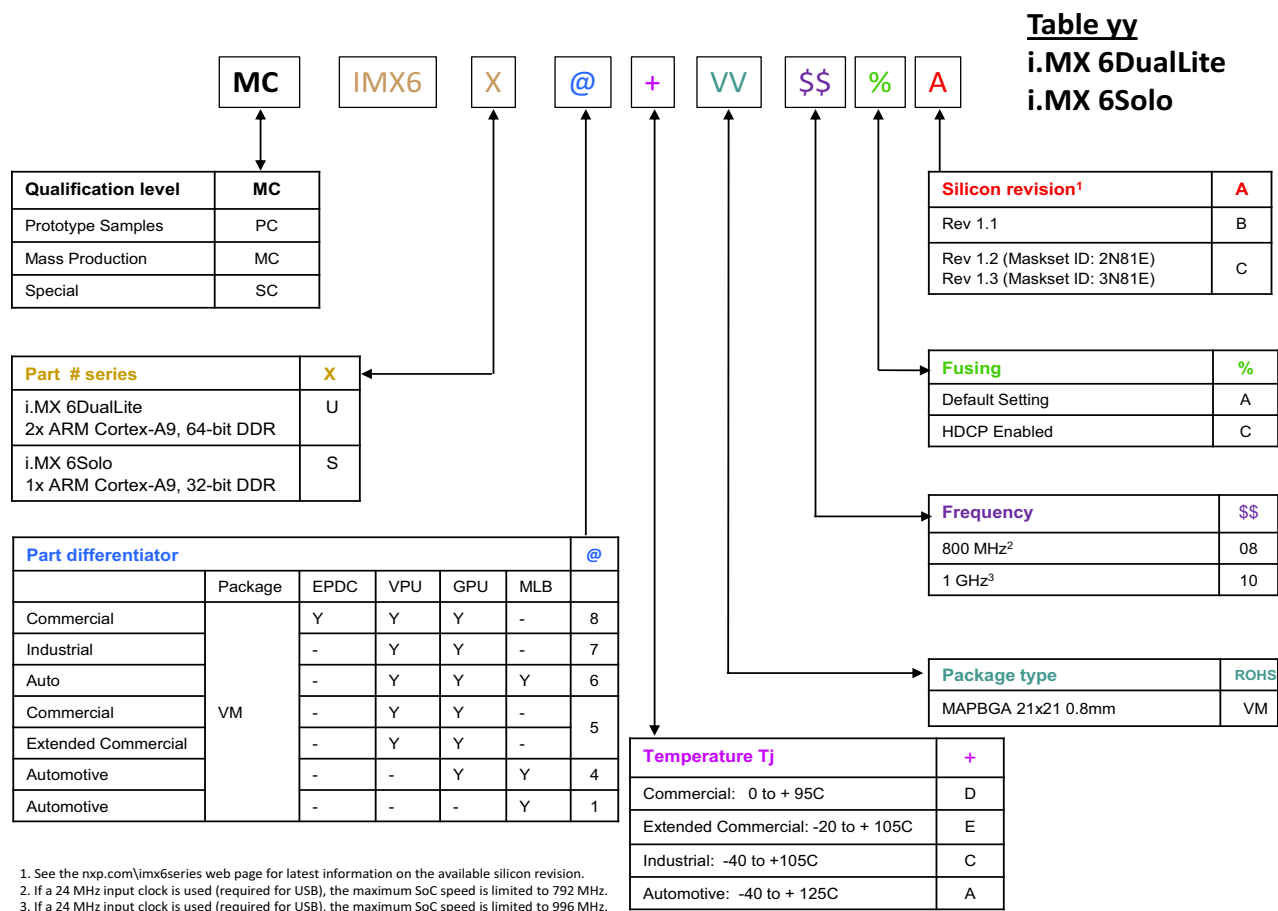
Figure 1 provides a cross-reference to match the revision code to the revision level marked on the device.

Figure 1. Revision Level to Part Marking Cross-Reference

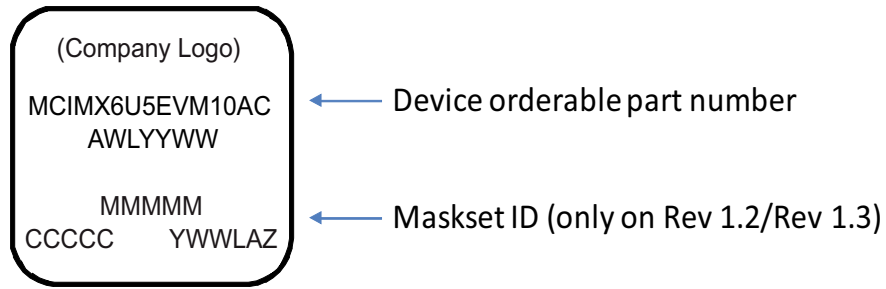
Figure 2 shows an example part marking for Revision 1.2/1.3 devices.

Figure 2. Example Part Marking for Revision 1.2/1.3 Devices
